THE ACCIDENT AT THE NUCLEAR FUEL PROCESSING FACILITY IN TOKAJMURA: THE ROLE OF IAEA

Dominique Delattre
Nuclear Safety Department
Division of Radiation and Waste Safety
International Atomic Energy Agency

2. The Preliminary Fact-Finding Mission Following the Accident at the Nuclear Fuel Processing Facility in Tokaimura, Japan

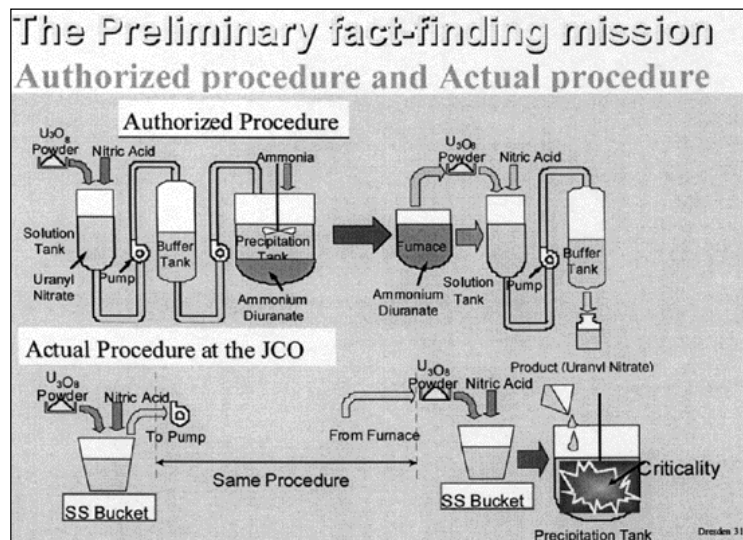
Furthermore, when the criticality event occurred, homogenization of uranium oxide was being performed by mechanical stirring in the precipitation tank instead of in the mass control equipment. This was done by pouring uranyl nitrate solution (made by dissolving uranium oxide (U_3O_8) in nitric acid) directly from the steel bucket into the precipitation tank. The tank was not designed with a geometry conducive to preventing criticality, being 450 mm in diameter and 610 mm high. This means of homogenization in the precipitation tank is not even described in the revised procedure and was a further deviation from the approved procedure.

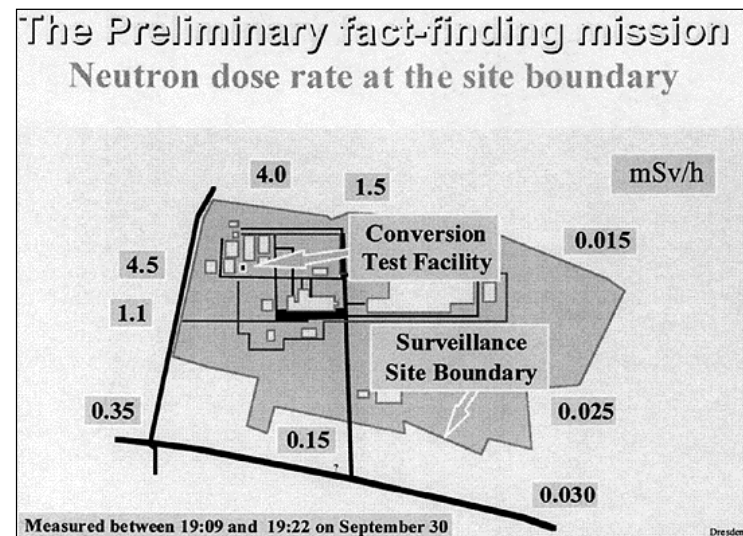
At around 10:35 on 30 September (all times are local times unless otherwise stated), when the volume of solution in the precipitation tank reached about 40 L, equivalent to about 16 kg U, a critical mass was reached. At the point of criticality, the nuclear fission chain reaction became self-sustaining and began to emit intense gamma and neutron radiation. The area gamma monitoring device detected a high level of gamma radiation and the area alarms sounded. The three workers concerned evacuated the building (there was apparently no explosion). They were subsequently given assistance by emergency service workers. The other workers on site assembled in the muster zone.

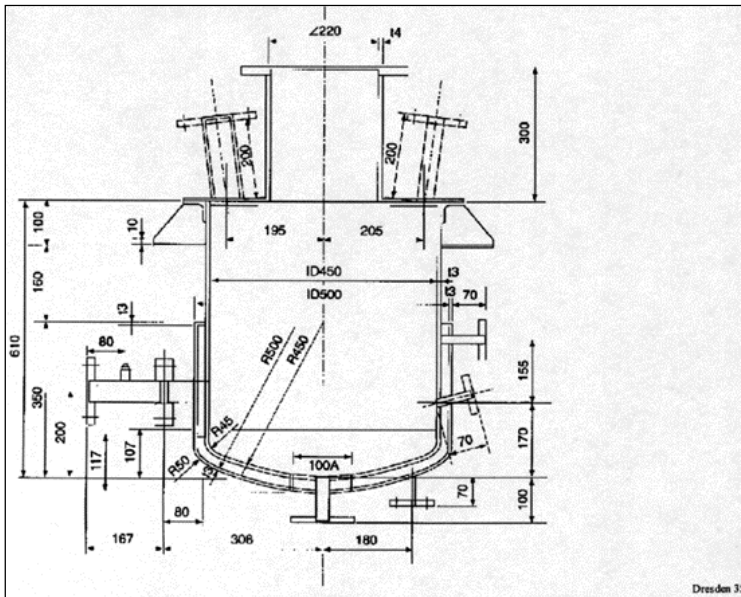
An investigation was made by the LCH by means of criticality modelling, which took about an hour. This computer modelling led to the conclusion that the removal of water from the cooling jacket could help to terminate the state of criticality.

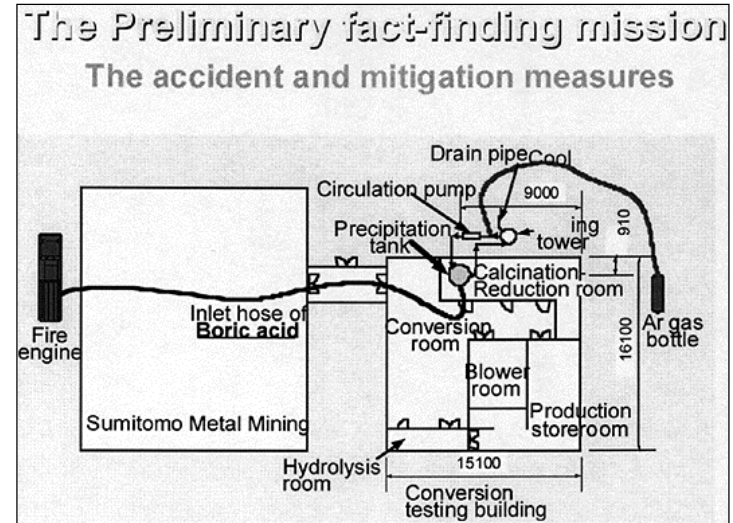
The cooling jacket acted as a neutron reflector, thereby enhancing nuclear fission. At the second meeting at the GACH, held at 23:15 on 30 September, it was concluded that the cooling water should be drawn off from the water jacket surrounding the precipitation tank in order to end the state of criticality and thereby terminate the self-sustaining nuclear chain reaction.

The cooling pump, the valves and the cooling tower were located outside the building, making them easier to access. Attempts to drain the water were made between 02:35 and 06:04 on 1 October. Ten approaches were made, the purpose of the first being to photograph the cooling tower and pump area. First the cooling tower feed valve was closed and the drain valve was opened. At this stage, only a little water was drained, but the neutron dose rate decreased somewhat. The water pipe was then broken and cut to drain the water. Finally, at around 06:15, argon gas was pumped into the water pipe to force out much more water. At around 06:30 the neutron dose rate was below the detection limit.

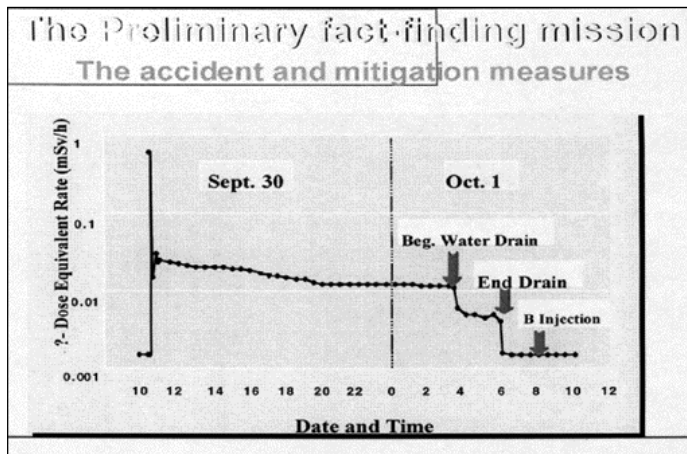
In parallel with the removal of water, preparations were made for the injection of aqueous boric acid in order to ensure that the state of the precipitation tank was and would remain subcritical. No boric acid was available at the JCO site, so it was brought from the Oarai Establishment in JAERI, 10 km away from the JCO site. The boric acid feeding Operation began at 08:19 on 1 October. A fire engine was used for the boric acid feed, which was reported to have been completed at 08:39 with a total volume of 17 L of solution with 25 g of boron per litre having been fed into the precipitation tank. A photograph was taken of the precipitation tank to ensure

that aqueous boric acid had been adequately injected. The photograph showed that no damage had been caused to the tank or to its surroundings. After inspection the operation was deemed to be completed at 09:18.
